**RADIOLOGICAL CHARACTERIZATION REPORT FOR
FUSRAP PROPERTIES IN THE ST. LOUIS, MISSOURI, AREA**

VOLUME I

MARCH 1990

**K. C. Noey
C. M. Sekula
Bechtel National, Inc.
Oak Ridge, Tennessee**

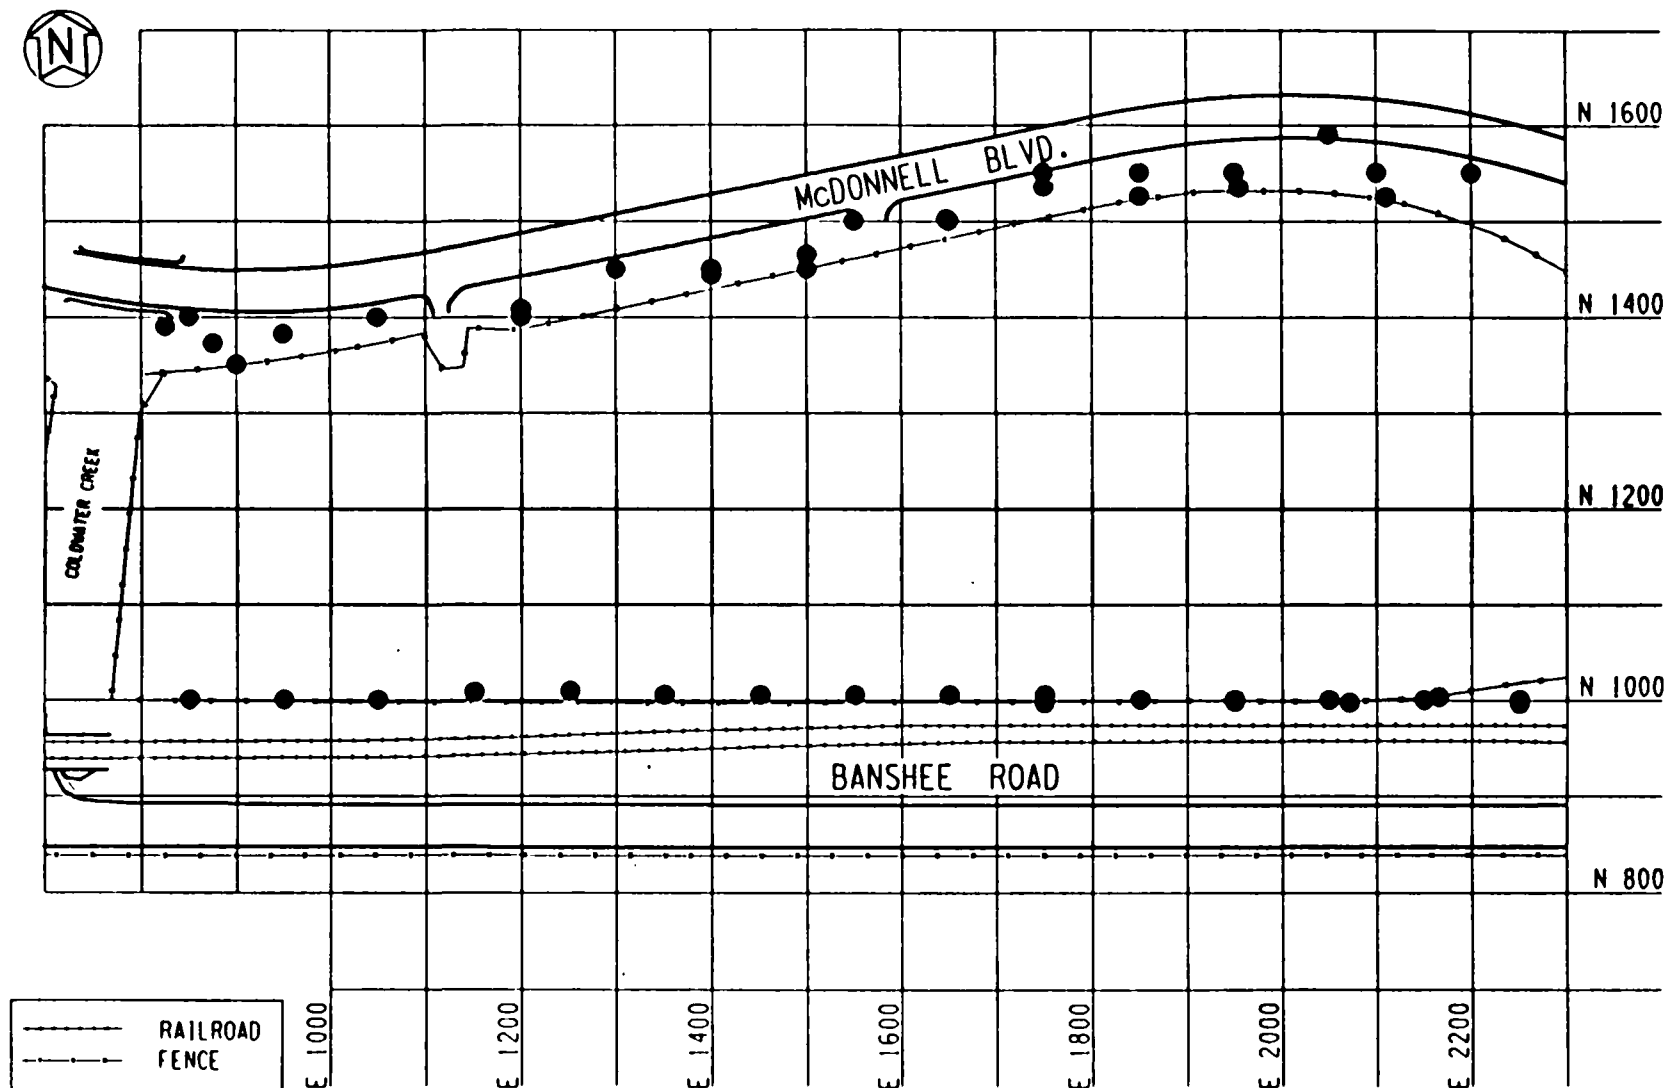
FIGURE 7-5 SUBSURFACE SOIL SAMPLING LOCATIONS FOR
RADIOLOGICAL CHARACTERIZATION OF THE DITCHES
TO THE NORTH AND SOUTH OF SLAPS

Surface soil sampling locations at the SLAPS ditches are shown in Figure 7-4. Subsurface sampling locations are shown in Figure 7-5. Analytical results for soil (Table 7-4) revealed areas with elevated concentrations of radium-226 and thorium-230 in surface and subsurface samples. Thorium-230 was identified as the major contaminant. Uranium-238 concentrations ranged from less than 1 to 94 pCi/g. Concentrations of radium-226 ranged from 0.7 to 130 pCi/g. Thorium-232 concentrations ranged from 0.7 to 6 pCi/g, and concentrations of thorium-230 ranged from 0.9 to 15,000 pCi/g. Areas and depths of radioactive contamination at the ditches adjacent to SLAPS are shown in Figure 7-6.

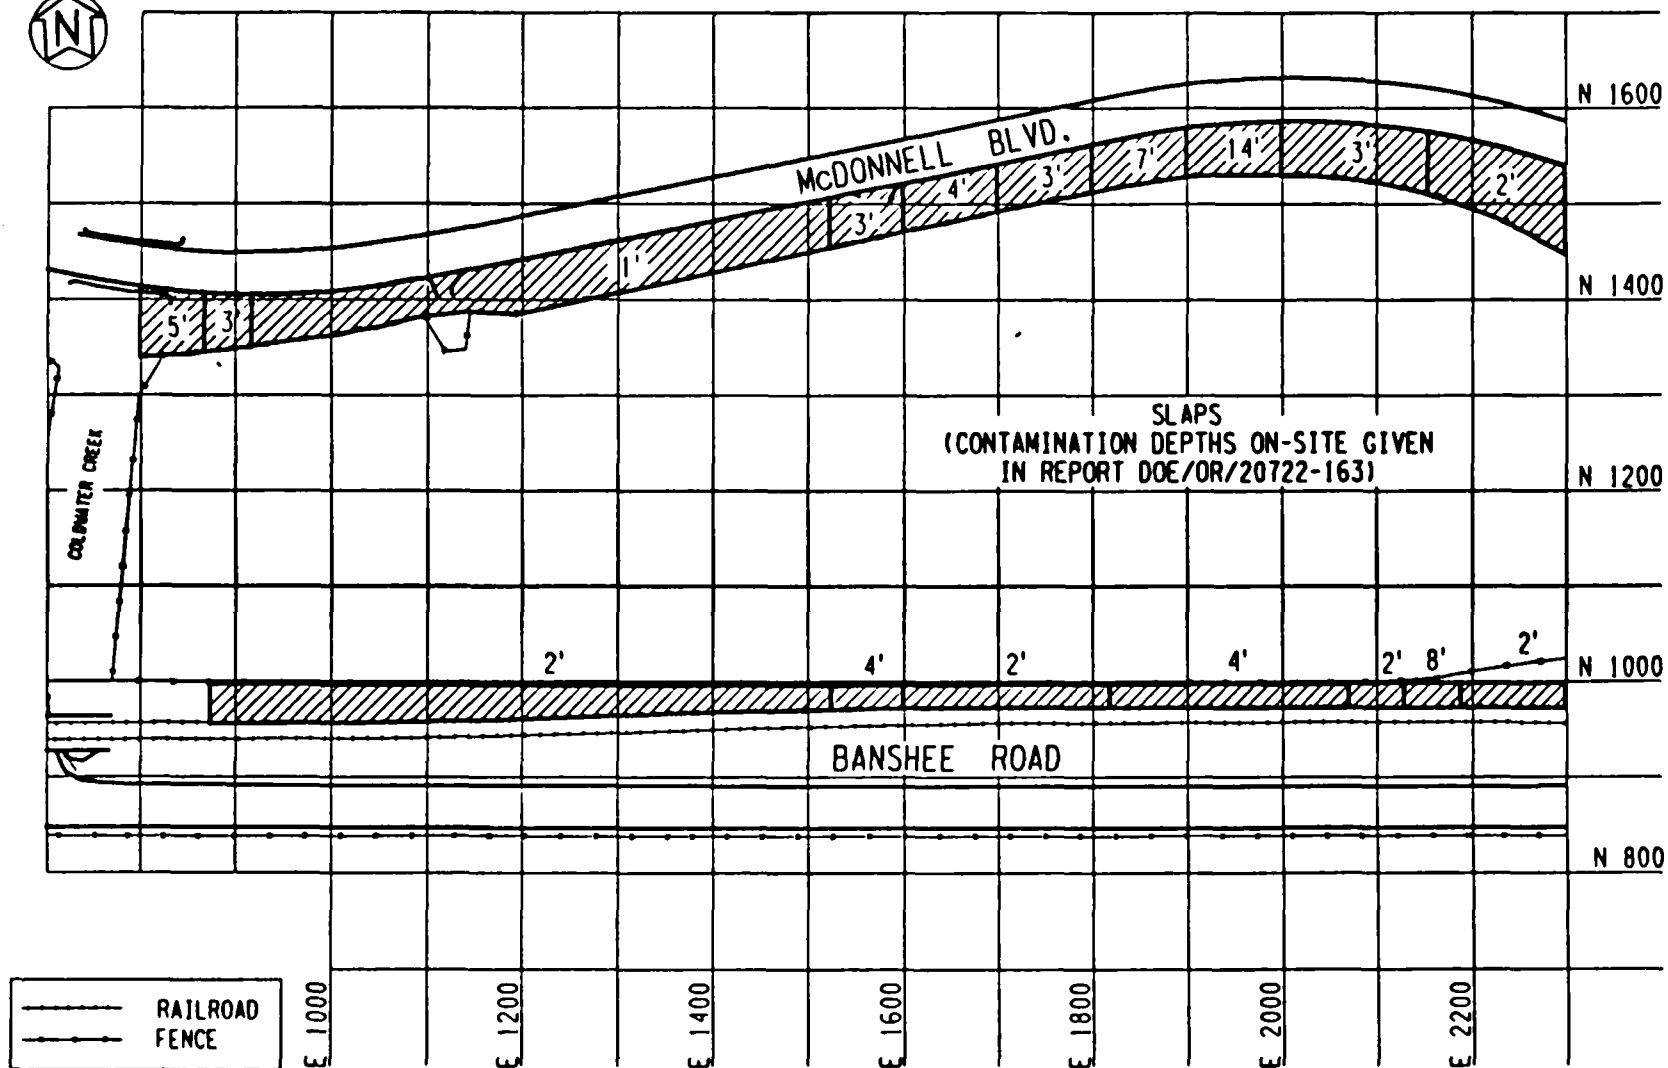
FIGURE 7-6 AREAS AND DEPTHS OF RADIOACTIVE CONTAMINATION AT THE DITCHES TO THE NORTH AND SOUTH OF SLAPS

Radioactive contamination (exceeding DOE guidelines) is present at two locations on Banshee Road, extending to a depth of 0.3 m (1 ft). Essentially all the ditch area north and south of SLAPS is contaminated ranging in depth from 0 to 4.3 m (0 to 14 ft). The 4.3-m (14-ft) depth of contamination occurred at one location. Radioactive contamination is present on the St. Louis Airport Authority property south of SLAPS, extending to a depth of 1.2 m (4 ft) at two locations. In general, the contamination is shallow [0.6 m (2 ft)] and extends the length of SLAPS between SLAPS and Banshee Road. There are several areas south of Banshee Road, on the airport property, that exhibited radioactive contamination in excess of DOE guidelines. These areas are shallow [0 to 0.6 m (0 to 2 ft)] and are confined to the area adjacent to Banshee Road. With the exception of the baseball infields, the ball field area does have radiological contamination to an average depth of 0.3 m (1 ft). Thorium-230 was identified as the primary contaminant on all these properties.
